**Flood Control Project Maintenance  
Levee Inspections**  
**LMA District Cover Sheet**  
**Spring 2017 Levee Inspection Results**

**Reclamation District No. 0524 Middle Roberts Island**

**Spring 2017 Levee Inspection Results**

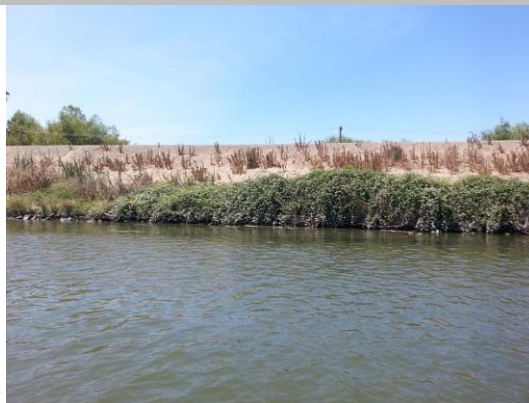
Photo 1 of 3 : SP\_2017\_RD0524\_107\_5\_20170316\_00011.jpg

LM Start	0.19	Rating **	U	Issue No.	5
LM End	0.19	Issue Type +	Ma	Location *	WS
Category	Supplemental			GPS Latitude/Longitude	
				Start	End
Item	DWR Erosion Survey			37.939085 °	37.939085 °
				-121.343917 °	-121.343917 °
DWR ID	DWR_RD0524_01_s_2017_5				
Comment Code					
Inspector Comment					
07/25/2016: No significant change observed.					
06/24/2015: No significant change observed.					
06/19/2014: No significant change observed.					
08/13/2013: The erosion was discovered during 2013 spring levee inspection. Inspector comment: Erosion is located along the lower level of water-ward slope. [2016 Site ID:RD0524U01RM40.85]

Close view of the erosion.

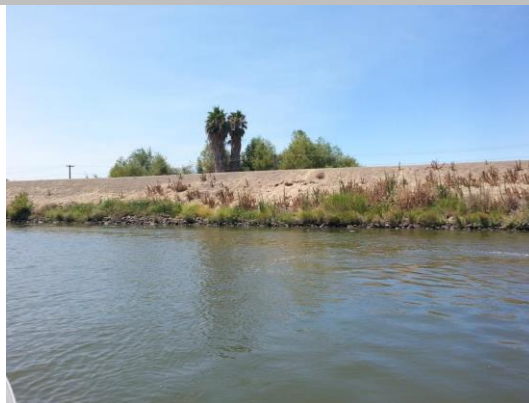
Photo 2 of 3 : SP\_2017\_RD0524\_107\_5\_20170316\_00012.jpg

LM Start	0.19	Rating **	U	Issue No.	5 (cont)	
LM End	0.19	Issue Type +	Ma	Location *	WS	
Category	Supplemental			GPS Latitude/Longitude		
				Start		End
Item	DWR Erosion Survey			37.939085 °		37.939085 °
				-121.343917 °		-121.343917 °
DWR ID	DWR_RD0524_01_s_2017_5					
Comment Code						
Inspector Comment						
07/25/2016: No significant change observed.						
06/24/2015: No significant change observed.						
06/19/2014: No significant change observed.						
08/13/2013: The erosion was discovered during 2013 spring levee inspection. Inspector comment: Erosion is located along the lower level of water-ward slope. [2016 Site ID:RD0524U01RM40.85]

Close view of the erosion.

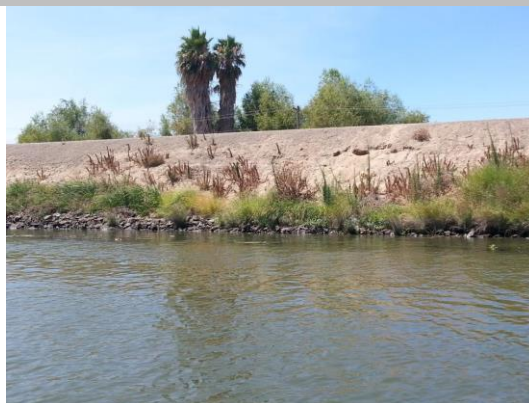
Photo 3 of 3 : SP\_2017\_RD0524\_107\_5\_20170316\_00013.jpg

Close view of the erosion.

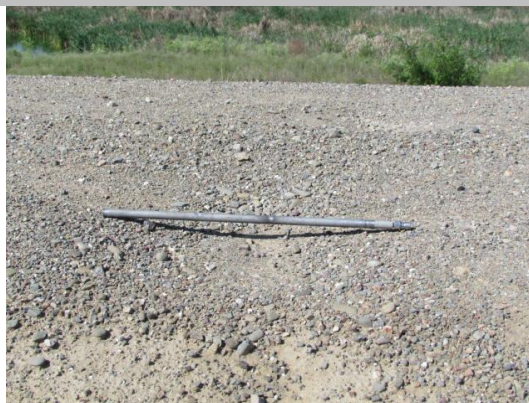
Photo 1 of 3 : SP\_2017\_RD0524\_107\_3\_20170316\_00007.jpg

LM Start	0.21	Rating **	M	Issue No.	3
LM End	0.21	Issue Type +	Ma	Location *	CR
Category	Earthen Levee			GPS Latitude/Longitude	
				Start	End
Item	Crown Surface / Depressions / Rutting			37.938890 °	37.938890 °
				-121.343657 °	-121.343657 °
DWR ID	DWR_RD0524_01_s_2016_3				
Comment Code					
C2 : Repair depressions or ruts in the crown or slope.					
Inspector Comment					
No change in status.

Looking west at 3" depression on levee crown. (Spring 2012)

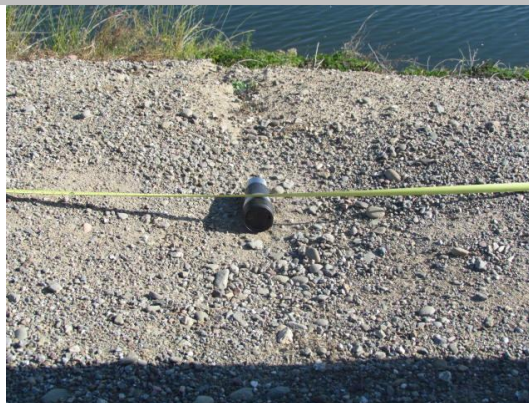
Photo 2 of 3 : SP\_2017\_RD0524\_107\_3\_20170316\_00008.jpg

LM Start	0.21	Rating **	M	Issue No.	3 (cont)	
LM End	0.21	Issue Type +	Ma	Location *	CR	
Category	Earthen Levee			GPS Latitude/Longitude		
				Start		End
Item	Crown Surface / Depressions / Rutting			37.938890 °		37.938890 °
				-121.343657 °		-121.343657 °
DWR ID	DWR_RD0524_01_s_2016_3					
Comment Code						
C2 : Repair depressions or ruts in the crown or slope.						
Inspector Comment						
No change in status.

Looking west at depression on levee crown near waterward shoulder.

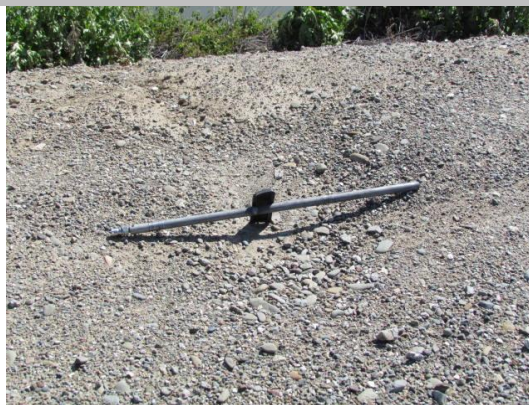
Photo 3 of 3 : SP\_2017\_RD0524\_107\_3\_20170316\_00009.jpg

Looking east at 3" depression on levee crown. (Spring 2012)

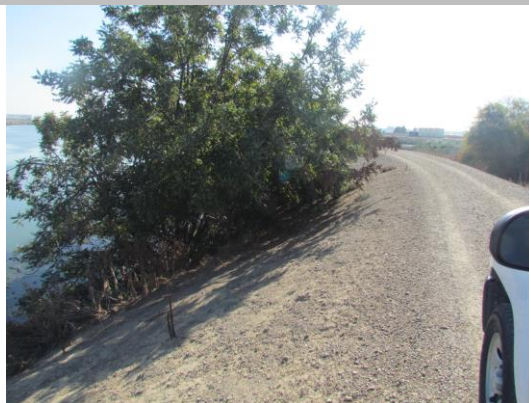
Photo 1 of 1 : SP\_2017\_RD0524\_107\_201\_20170316\_00232.jpg

LM Start	0.23	Rating **	U	Issue No.	201
LM End	0.23	Issue Type +	Ma	Location *	WS
Category	Earthen Levee			GPS Latitude/Longitude	
				Start	End
Item	Trim / Thin Trees			37.938648 °	37.938648 °
				-121.343480 °	-121.343480 °
DWR ID	DWR_RD0524_01_f_2016_201				
Comment Code					
T2 : Thin trees to allow visibility of the ground and room to flood fight.					
Inspector Comment					
Untrimmed trees on waterward slope.

Looking east at untrimmed tree on landward slope.

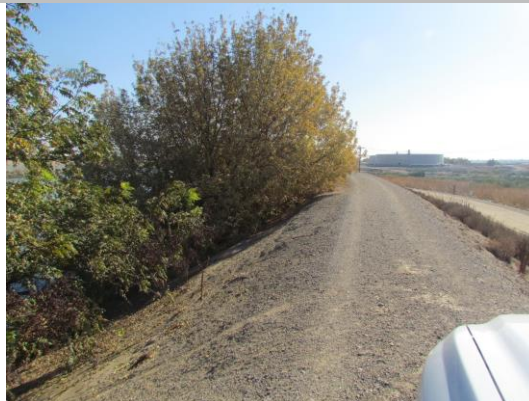
Photo 1 of 4 : SP\_2017\_RD0524\_107\_179\_20170316\_00212.jpg

Looking east at untrimmed tree on waterward slope. (Fall 2016)

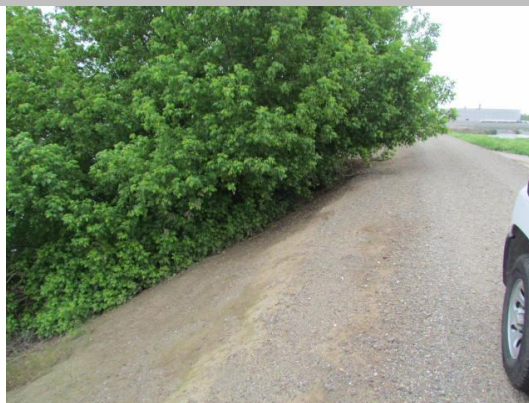
Photo 2 of 4 : SP\_2017\_RD0524\_107\_179\_20170316\_00213.jpg

Looking east at untrimmed tree on waterward slope (Spring 2016)

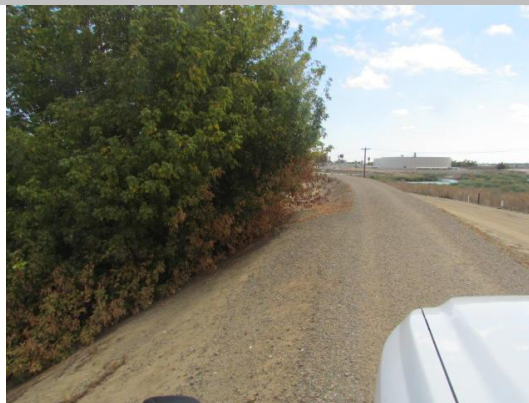
Photo 4 of 4 : SP\_2017\_RD0524\_107\_179\_20170316\_00215.jpg

LM Start	0.27	Rating **	U	Issue No.	179 (cont)	
LM End	0.27	Issue Type +	Ma	Location *	WS	
Category	Earthen Levee			GPS Latitude/Longitude		
				Start		End
Item	Trim / Thin Trees			37.938438 °	37.938438 °	
				-121.342883 °	-121.342883 °	
DWR ID	DWR_RD0524_01_s_2014_179					
Comment Code						
T2 : Thin trees to allow visibility of the ground and room to flood fight.						
Inspector Comment						
Tree blocking view of waterward slope.

Looking east at untrimmed tree on waterward slope. (Fall 2015)

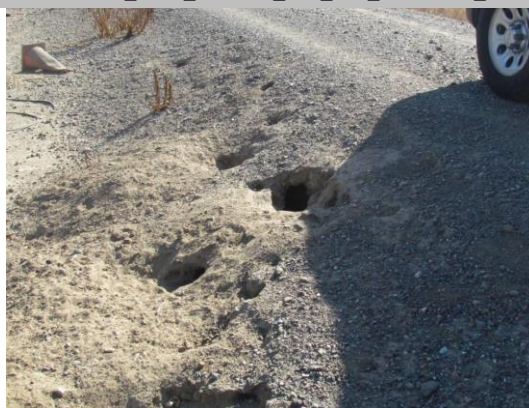
Photo 1 of 4 : SP\_2017\_RD0524\_107\_174\_20170316\_00204.jpg

LM Start	0.30	Rating **	U	Issue No.	174
LM End	0.30	Issue Type +	Ma	Location *	WS
Category	Earthen Levee			GPS Latitude/Longitude	
				Start	End
Item	Animal Control			37.938382 °	37.938382 °
				-121.342352 °	-121.342352 °
DWR ID	DWR_RD0524_01_f_2014_174				
Comment Code					
A1 : Exterminate rodents and backfill and compact or grout burrows.					
Inspector Comment					
Several rodent holes present at this site. No change at site during spring 2016 inspection.					
Active rodent activity during spring 2017 inspection. No change at site.

Looking southwest at several rodent holes on waterward slope. (Fall 2016)

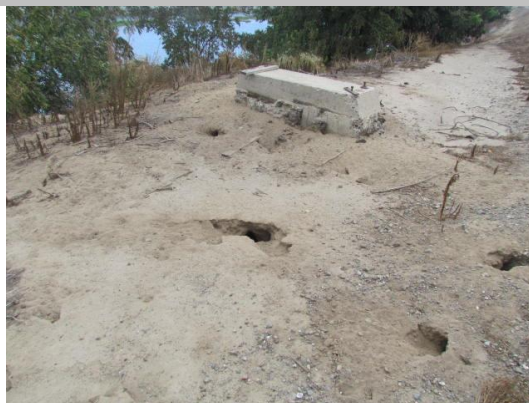
Photo 2 of 4 : SP\_2017\_RD0524\_107\_174\_20170316\_00205.jpg

Looking southeast at several rodent holes on waterward slope. (Spring 2016)

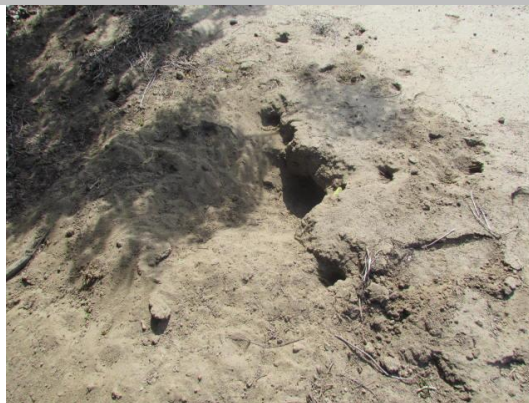
Photo 3 of 4 : SP\_2017\_RD0524\_107\_174\_20170316\_00206.jpg

LM Start	0.30	Rating **	U	Issue No.	174 (cont)	
LM End	0.30	Issue Type +	Ma	Location *	WS	
Category	Earthen Levee			GPS Latitude/Longitude		
				Start		End
Item	Animal Control			37.938382 °		37.938382 °
				-121.342352 °		-121.342352 °
DWR ID	DWR_RD0524_01_f_2014_174					
Comment Code						
A1 : Exterminate rodents and backfill and compact or grout burrows.						
Inspector Comment						
Several rodent holes present at this site. No change at site during spring 2016 inspection.						
Active rodent activity during spring 2017 inspection. No change at site.

Looking west at several rodent holes on waterward shoulder. (Spring 2015)

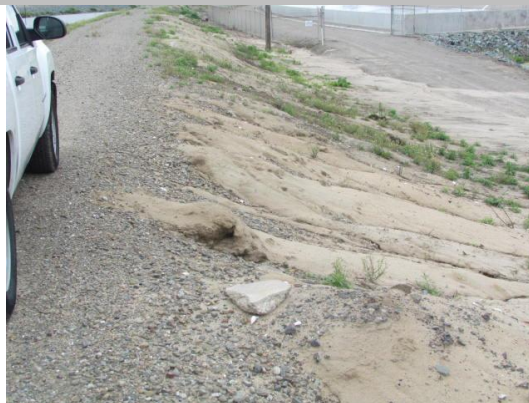
Photo 2 of 2 : SP\_2017\_RD0524\_107\_205\_20170316\_00238.jpg

LM Start	0.40	Rating **	U	Issue No.	205
LM End	0.46	Issue Type +	Ma	Location *	LS
Category	Earthen Levee			GPS Latitude/Longitude	
				Start	End
Item	Erosion / Bank Caving			37.938625 °	37.938695 °
				-121.340479 °	-121.339420 °
DWR ID	DWR_RD0524_01_s_2016_205				
Comment Code					
E2 : Schedule repair of erosion site prior to the next inspection.					
Inspector Comment					
Several damage site within this reach.

Looking at slope damage on landward slope.

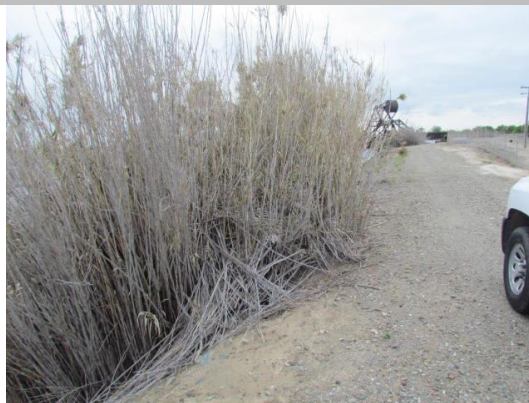
Photo 1 of 5 : SP\_2017\_RD0524\_107\_11\_20170316\_00020.jpg

LM Start	0.62	Rating **	U	Issue No.	11
LM End	0.63	Issue Type +	Ma	Location *	WS
Category	Earthen Levee			GPS Latitude/Longitude	
				Start	End
Item	Vegetation			37.938278 °	37.938247 °
				-121.336524 °	-121.336503 °
DWR ID	DWR_RD0524_01_s_2012_11				
Comment Code					
V2 : Remove the wild growth other than native grasses from the levee slopes.					
Inspector Comment					
Bamboo on waterward slope. Bamboo has been killed but still blocking view of waterward slope.

Looking at bamboo on waterward slope. (Spring 2016)

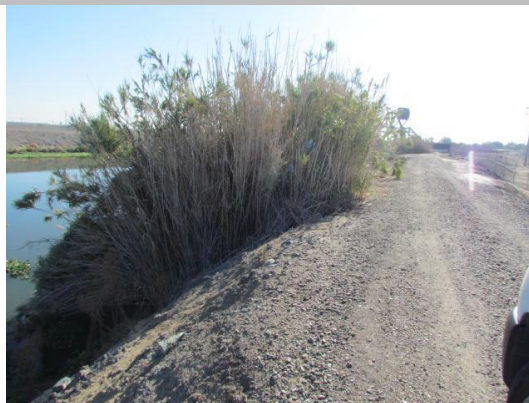
Photo 2 of 5 : SP\_2017\_RD0524\_107\_11\_20170316\_00021.jpg

Looking at bamboo on waterside slope. (Fall 2015)

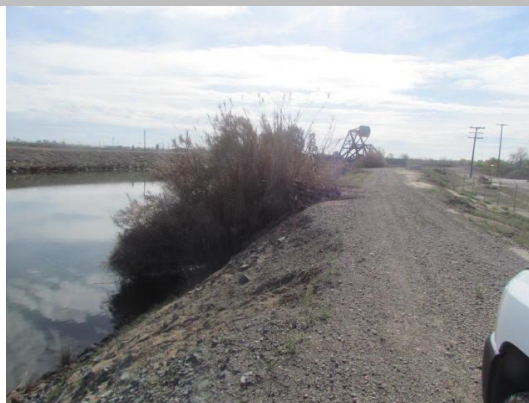
Photo 3 of 5 : SP\_2017\_RD0524\_107\_11\_20170316\_00022.jpg

Looking at dying bamboo on waterward slope. (Spring 2013)

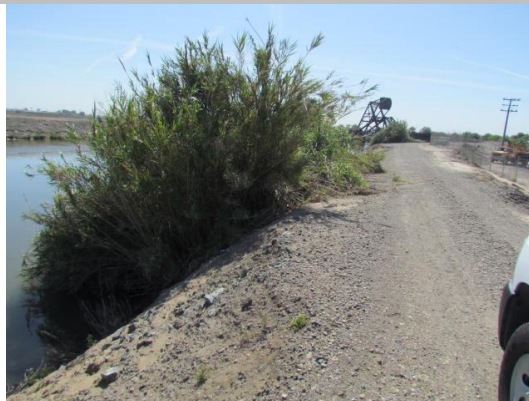
Photo 4 of 5 : SP\_2017\_RD0524\_107\_11\_20170316\_00023.jpg

Looking at bamboo on waterside slope. (Spring 2012)

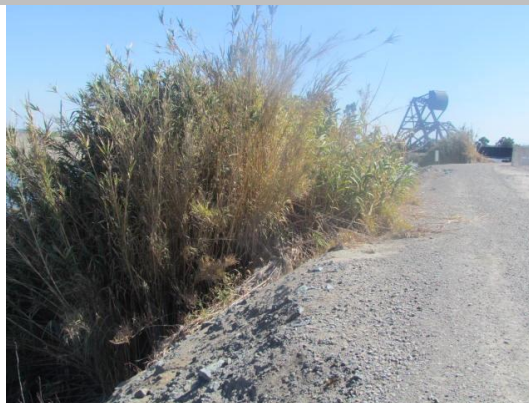
Photo 5 of 5 : SP\_2017\_RD0524\_107\_11\_20170316\_00024.jpg

LM Start	0.62	Rating **	U	Issue No.	11 (cont)	
LM End	0.63	Issue Type +	Ma	Location *	WS	
Category	Earthen Levee			GPS Latitude/Longitude		
				Start		End
Item	Vegetation			37.938278 °		37.938247 °
				-121.336524 °		-121.336503 °
DWR ID	DWR_RD0524_01_s_2012_11					
Comment Code						
V2 : Remove the wild growth other than native grasses from the levee slopes.						
Inspector Comment						
Bamboo on waterward slope. Bamboo has been killed but still blocking view of waterward slope.

Looking at bamboo on waterside slope. (Fall Inspection 2012)

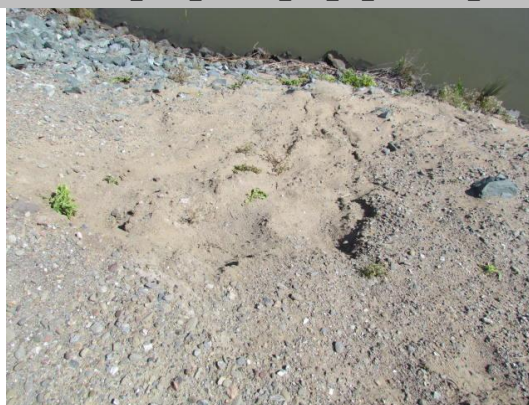
Photo 1 of 3 : SP\_2017\_RD0524\_107\_10\_20170316\_00017.jpg

LM Start	0.63	Rating **	U	Issue No.	10
LM End	0.63	Issue Type +	Ma	Location *	WS
Category	Earthen Levee			GPS Latitude/Longitude	
				Start	End
Item	Erosion / Bank Caving			37.938247 °	37.938247 °
				-121.336503 °	-121.336503 °
DWR ID	DWR_RD0524_01_f_2015_10				
Comment Code					
E2 : Schedule repair of erosion site prior to the next inspection.					
Inspector Comment					
Erosion located next to and under bamboo.

Looking east at waterside erosion appears to be caused by runoff.

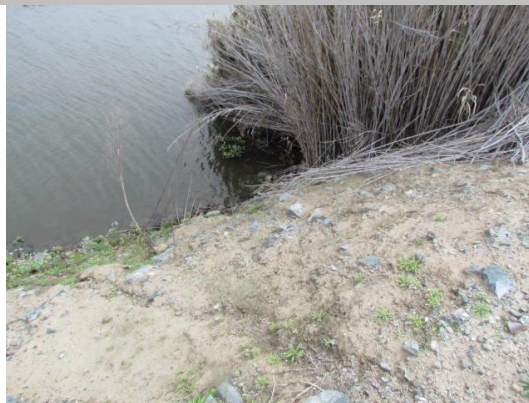
Photo 3 of 3 : SP\_2017\_RD0524\_107\_10\_20170316\_00019.jpg

LM Start	0.63	Rating **	U	Issue No.	10 (cont)	
LM End	0.63	Issue Type +	Ma	Location *	WS	
Category	Earthen Levee			GPS Latitude/Longitude		
				Start		End
Item	Erosion / Bank Caving			37.938247 °		37.938247 °
				-121.336503 °		-121.336503 °
DWR ID	DWR_RD0524_01_f_2015_10					
Comment Code						
E2 : Schedule repair of erosion site prior to the next inspection.						
Inspector Comment						
Erosion located next to and under bamboo.

Looking east at erosion under bamboo on waterward slope.

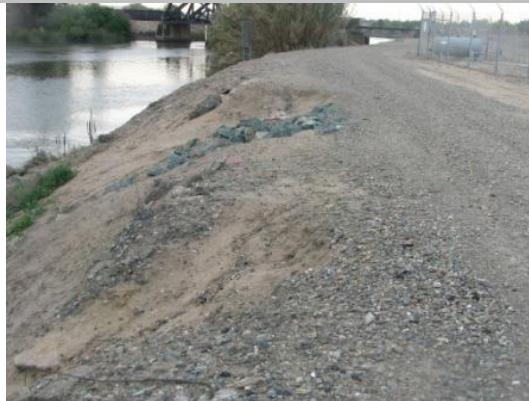
Photo 3 of 4 : SP\_2017\_RD0524\_107\_13\_20170316\_00028.jpg

LM Start	0.64	Rating **	M	Issue No.	13 (cont)	
LM End	0.65	Issue Type +	Ma	Location *	WS	
Category	Earthen Levee			GPS Latitude/Longitude		
				Start		End
Item	Slope Stability			37.938105 °		37.938023 °
				-121.336288 °		-121.336173 °
DWR ID	DWR_RD0524_01_s_2012_13					
Comment Code						
S1 : Repair slope instability.						
Inspector Comment						
Depression extend from shoulder to mid levee slope two site with this section.

View of the erosion.

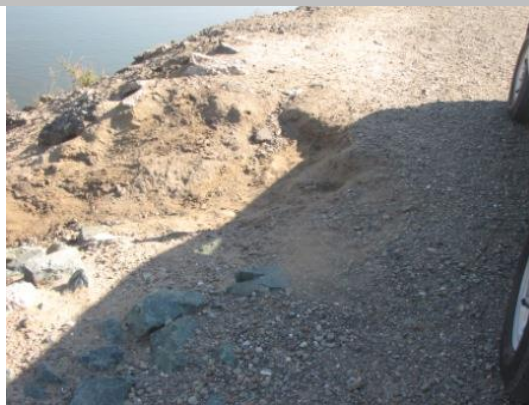
Photo 4 of 4 : SP\_2017\_RD0524\_107\_13\_20170316\_00029.jpg

Update view of the erosion site.

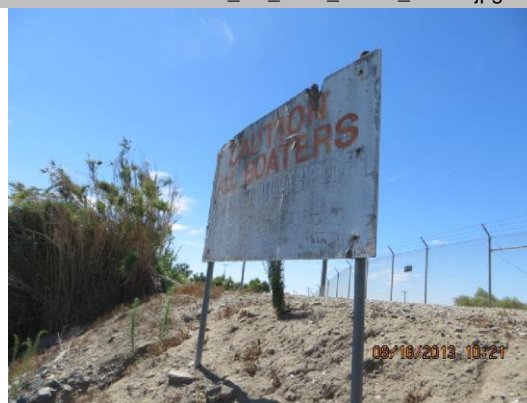
Photo 1 of 3 : UCIP\_SP\_2017\_17563\_29702.jpg

LM Start	0.67	Rating **	M	Issue No.	934
LM End	0.67	Issue Type +	En	Location *	WS
Category	Supplemental			GPS Latitude/Longitude	
				Start	End
Item	DWR UCIP Field Study			37.937891 °	37.937891 °
				-121.335939 °	-121.335939 °
DWR ID					
Comment Code					
Inspector Comment					
FS_ID:17563 DS_ID:20592 EP_NO: 6035 Repair Type: Non-Urgent Crossing Status: Found UCIP Comments: Flows from primer tank causing erosion on LS slope. FIELD_STRUCT_DESC: 48-inch pipe through levee 7.3 feet below crown. Siphon pumps and primer tank enclosed by cyclone fence on the landward shoulder. Gate valve at inlet sump 100-feet off LS toe. One concrete cutoff wall. (Permit No. 6035, 1968). FS Date: 8/16/2013

Signage for effluent pipe on WS shoulder.

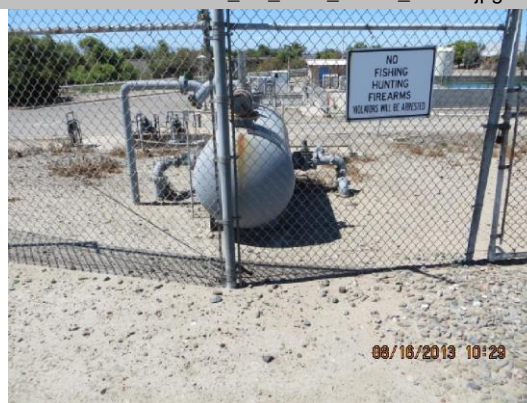
Photo 2 of 3 : UCIP\_SP\_2017\_17563\_29701.jpg

Siphon Priming tank and associated pipes on LS shoulder.

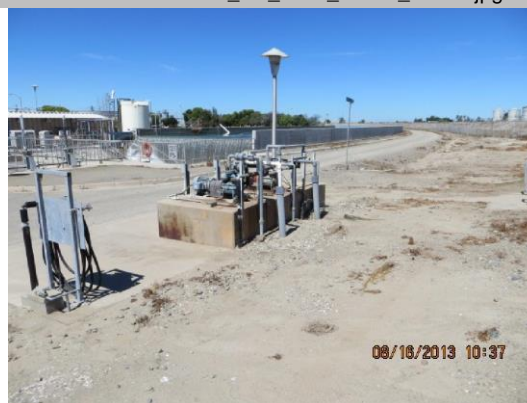
Photo 3 of 3 : UCIP\_SP\_2017\_17563\_29700.jpg

LM Start	0.67	Rating **	M	Issue No.	934 (cont)
LM End	0.67	Issue Type +	En	Location *	WS
Category	Supplemental			GPS Latitude/Longitude	
				Start	End
Item	DWR UCIP Field Study			37.937891 °	37.937891 °
				-121.335939 °	-121.335939 °
DWR ID					
Comment Code					
Inspector Comment					
FS_ID:17563 DS_ID:20592 EP_NO: 6035 Repair Type: Non-Urgent Crossing Status: Found UCIP Comments: Flows from primer tank causing erosion on LS slope. FIELD_STRUCT_DESC: 48-inch pipe through levee 7.3 feet below crown. Siphon pumps and primer tank enclosed by cyclone fence on the landward shoulder. Gate valve at inlet sump 100-feet off LS toe. One concrete cutoff wall. (Permit No. 6035, 1968). FS Date: 8/16/2013

Vacuum pumps off LS toe.

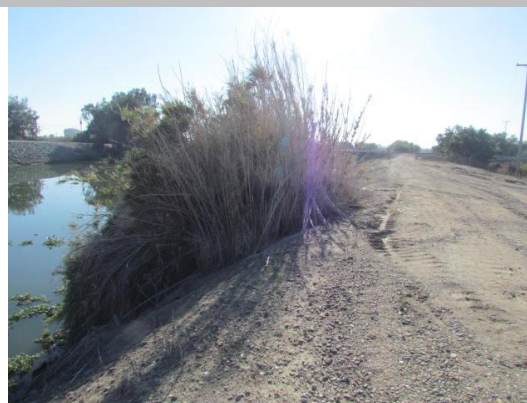
Photo 1 of 3 : SP\_2017\_RD0524\_107\_14\_20170316\_00030.jpg

LM Start	0.67	Rating **	U	Issue No.	14
LM End	0.67	Issue Type +	Ma	Location *	WS
Category	Earthen Levee			GPS Latitude/Longitude	
				Start	End
Item	Vegetation			37.937808 °	37.937808 °
				-121.335913 °	-121.335913 °
DWR ID	DWR_RD0524_01_s_2012_14				
Comment Code					
V2 : Remove the wild growth other than native grasses from the levee slopes.					
Inspector Comment					
Bamboo on waterward slope.Bamboo has been killed but still blocking view of levee slope.

Looking south at dying bamboo on waterward slope. Fall 2015

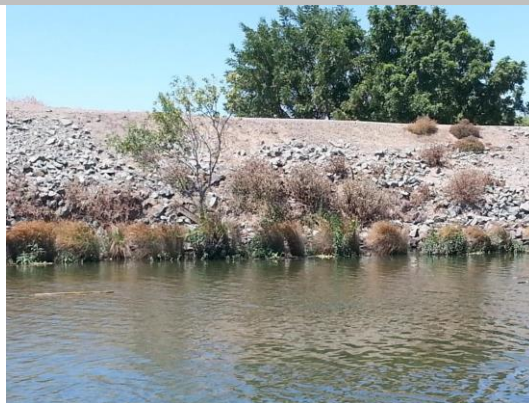
Photo 1 of 1 : SP\_2017\_RD0524\_107\_17\_20170316\_00035.jpg

LM Start	0.71	Rating **	M	Issue No.	17
LM End	0.73	Issue Type +	Ma	Location *	WS
Category	Supplemental			GPS Latitude/Longitude	
				Start	End
Item	DWR Erosion Survey			37.937222 °	37.937222 °
				-121.335277 °	-121.335277 °
DWR ID	DWR_RD0524_01_s_2017_17				
Comment Code					
Inspector Comment					
07/25/2016: No significant change observed.					
06/24/2015: The erosion site is immediately downstream of the RR bridge. [2016 Site ID:RD0524U01RM41.36]

Close view of the erosion.

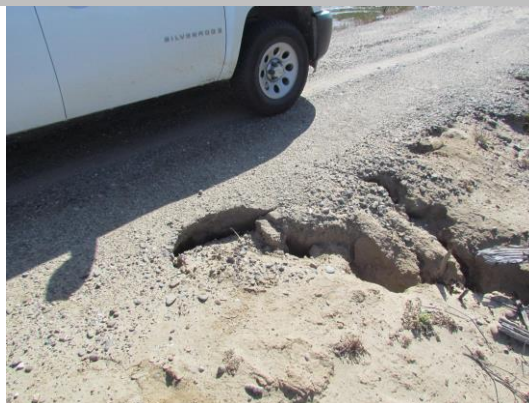
Photo 2 of 2 : SP\_2017\_RD0524\_107\_157\_20170407\_00381.jpg

LM Start	0.72	Rating **	U	Issue No.	157
LM End	0.72	Issue Type +	Ma	Location *	LS
Category	Earthen Levee			GPS Latitude/Longitude	
				Start	End
Item	Erosion / Bank Caving			37.937290 °	37.937290 °
				-121.335417 °	-121.335417 °
DWR ID	DWR_RD0524_01_s_2017_157				
Comment Code					
Inspector Comment					
Slope damage caused by rain runoff on landward slope.

Looking south at slope damage caused by rain runoff on landward slope.

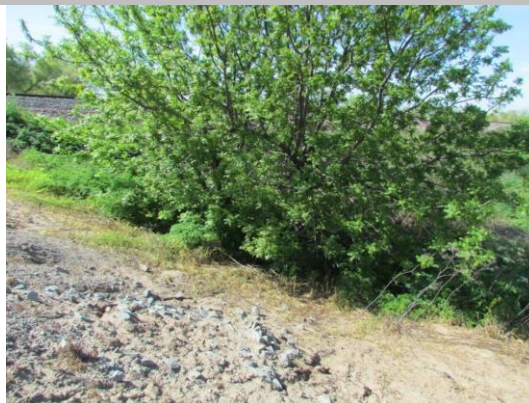
Photo 1 of 1 : SP\_2017\_RD0524\_107\_156\_20170407\_00382.jpg

LM Start	0.72	Rating **	U	Issue No.	156
LM End	0.72	Issue Type +	Ma	Location *	LS
Category	Earthen Levee			GPS Latitude/Longitude	
				Start	End
Item	Trim / Thin Trees			37.937258 °	37.937258 °
				-121.335373 °	-121.335373 °
DWR ID	DWR_RD0524_01_s_2017_156				
Comment Code					
T1 : Trim trees to at least five feet above ground level.					
Inspector Comment					
Dense veg on landward slope.

Looking west at dense untrimmed tree on landward slope.

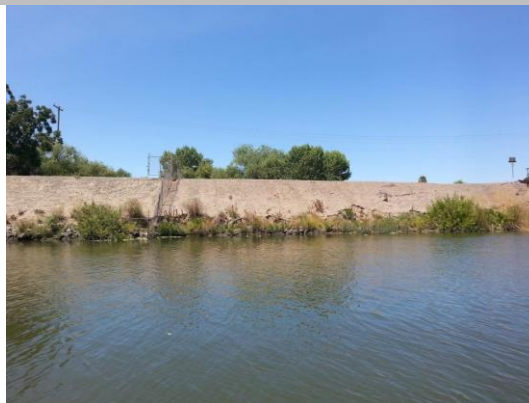
Photo 2 of 2 : SP\_2017\_RD0524\_107\_21\_20170316\_00045.jpg

LM Start	0.76	Rating **	U	Issue No.	21 (cont)	
LM End	0.77	Issue Type +	Ma	Location *	WS	
Category	Supplemental			GPS Latitude/Longitude		
				Start		End
Item	DWR Erosion Survey			37.936821 °		37.936821 °
				-121.334582 °		-121.334582 °
DWR ID	DWR_RD0524_01_s_2017_21					
Comment Code						
Inspector Comment						
07/25/2016: No significant change observed.						
06/24/2015: No significant change observed.						
06/19/2014: No significant change observed.						
08/13/2013: No significant change at this site.						
08/07/2012: The site has been visited by boat survey. No significant change observed.						
08/23/2011: The site is located immediately upstream of a Railroad bridge. Dense vegetation at the water line blocks the view of erosion.						
[2016 Site ID:RD0524U01RM41.39]

Front view of the erosion.

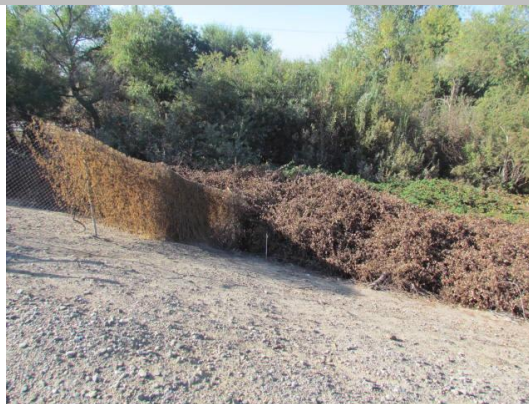
Photo 1 of 3 : SP\_2017\_RD0524\_107\_262\_20170316\_00261.jpg

LM Start	0.77	Rating **	U	Issue No.	262
LM End	0.77	Issue Type +	Ma	Location *	LS
Category	Earthen Levee			GPS Latitude/Longitude	
				Start	End
Item	Vegetation			37.936555 °	37.936555 °
				-121.334847 °	-121.334847 °
DWR ID	DWR_RD0524_01_s_2012_262				
Comment Code					
V2 : Remove the wild growth other than native grasses from the levee slopes.					
Inspector Comment					
Dense vegetation at landside toe along fence line.

Looking west at dense vegetation at landward slope and toe fall 2015.

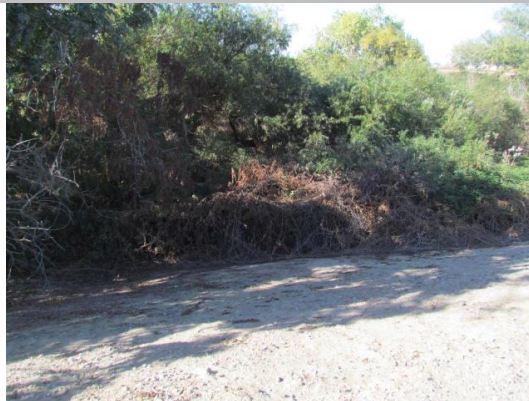
Photo 2 of 3 : SP\_2017\_RD0524\_107\_262\_20170316\_00262.jpg

Looking west at dense vegetation on landside toe. Spring 2014

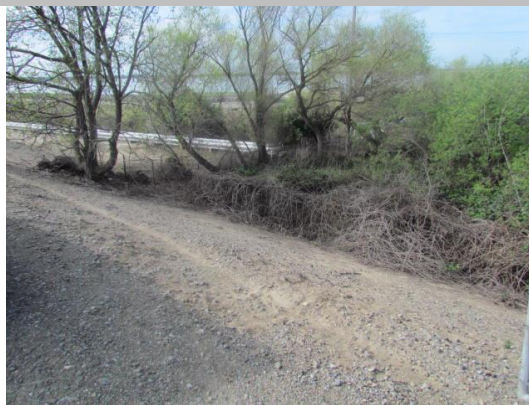
Photo 3 of 3 : SP\_2017\_RD0524\_107\_262\_20170316\_00263.jpg

Looking southwest at vegetation on landward slope and toe. (Spring 2013)

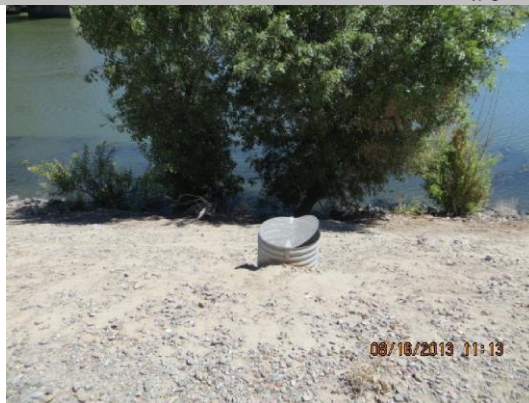
Photo 1 of 2 : UCIP\_SP\_2017\_17571\_29719.jpg

LM Start	0.78	Rating **	M	Issue No.	936
LM End	0.78	Issue Type +	Ma	Location *	LS
Category	Supplemental			GPS Latitude/Longitude	
				Start	End
Item	DWR UCIP LMA Responsibility			37.936474 °	37.936474 °
				-121.334830 °	-121.334830 °
DWR ID					
Comment Code					
Inspector Comment					
FS_ID:17571					
DS_ID:20596					
EP_NO: N/A					
Repair Type: Non-Urgent					
Crossing Status: Found					
UCIP Comments: Large hole in pipe at WS toe. Appears abandoned and should be done so properly.					
FIELD_STRUCT_DESC: 8-inch steel drain pipe through the levee 4.0 feet below the crown. Pump at the toe of the landward slope (not found 8/16/13). Siphon breaker in 24-inch cmp Riser on the waterward slope. Originally included in the 1964 O&M manual.					
FS Date: 8/16/2013

Siphon breaker in 24-inch cmp riser on WS slope.

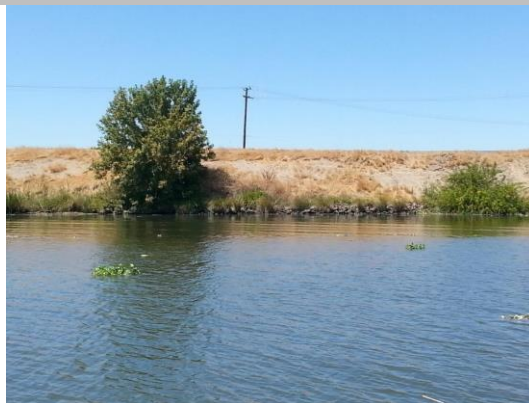
Photo 2 of 2 : SP\_2017\_RD0524\_107\_22\_20170316\_00047.jpg

LM Start	0.83	Rating **	U	Issue No.	22 (cont)	
LM End	0.84	Issue Type +	Ma	Location *	WS	
Category	Supplemental			GPS Latitude/Longitude		
				Start		End
Item	DWR Erosion Survey			37.935930 °	37.935930 °	
				-121.334133 °	-121.334133 °	
DWR ID	DWR_RD0524_01_s_2017_22					
Comment Code						
Inspector Comment						
07/25/2016: No significant change observed.						
06/24/2015: No significant change observed.						
06/19/2014: No significant change observed.						
08/13/2013: Site was discovered during boat survey. The dense vegetation blocks a clear view of the erosion. Size of erosion site was very roughly estimated. [2016 Site ID:RD0524U01RM41.44]

Front view of the erosion.

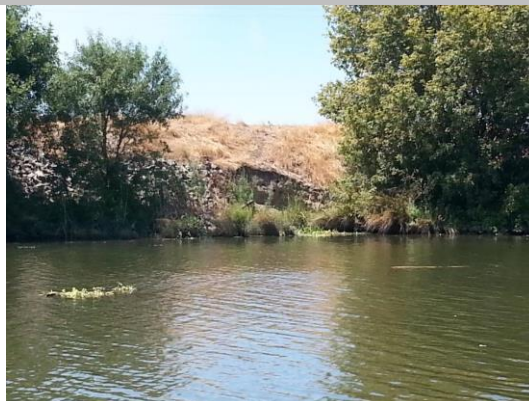
Photo 1 of 2 : SP\_2017\_RD0524\_107\_33\_20170316\_00063.jpg

LM Start	0.91	Rating **	U	Issue No.	33
LM End	0.91	Issue Type +	Ma	Location *	WS
Category	Supplemental			GPS Latitude/Longitude	
				Start	End
Item	DWR Erosion Survey			37.935576 °	37.935576 °
				-121.333202 °	-121.333202 °
DWR ID	DWR_RD0524_01_s_2017_33				
Comment Code					
Inspector Comment					
07/25/2016: No significant change observed.					
06/24/2015: No significant change observed.					
06/19/2014: No significant change observed.					
08/13/2013: No significant change at this site.					
08/07/2012: The site has been visited by boat survey. No significant change observed					
08/23/2011: The erosion site is immediately downstream of the riprap protection. [2016 Site ID:RD0524U01RM41.5]

Front view of the erosion. Note the riprap protection near the site.

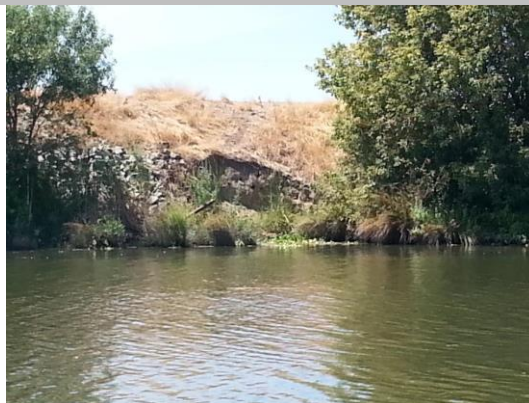
Photo 2 of 2 : SP\_2017\_RD0524\_107\_33\_20170316\_00064.jpg

Close view of the erosion.

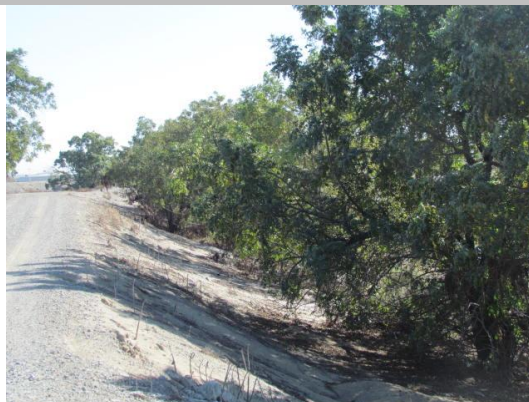
Photo 1 of 1 : SP\_2017\_RD0524\_107\_77\_20170316\_00125.jpg

LM Start	0.93	Rating **	U	Issue No.	77
LM End	1.01	Issue Type +	Ma	Location *	LS
Category	Earthen Levee			GPS Latitude/Longitude	
				Start	End
Item	Trim / Thin Trees			37.935259°	37.935049°
				-121.332864°	-121.331334°
DWR ID	DWR_RD0524_01_s_2012_77				
Comment Code					
T1 : Trim trees to at least five feet above ground level.					
Inspector Comment

Looking south at low hanging tree branches at landside toe.

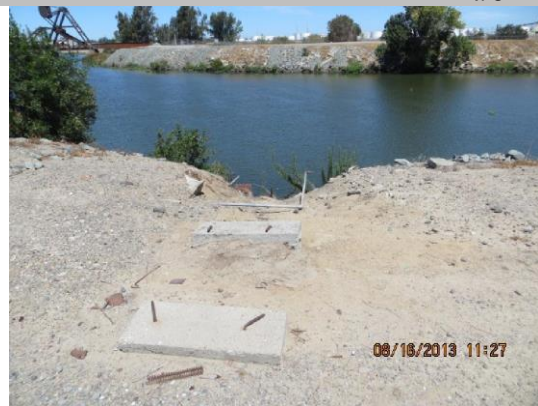
Photo 1 of 3 : UCIP\_SP\_2017\_22724\_38442.jpg

LM Start	0.97	Rating **	M	Issue No.	937
LM End	0.97	Issue Type +	En	Location *	WS
Category	Supplemental			GPS Latitude/Longitude	
				Start	End
Item	DWR UCIP Field Study			37.935178 °	37.935178 °
				-121.332029 °	-121.332029 °
DWR ID					
Comment Code					
Inspector Comment					
FS_ID:22724 DS_ID:20597 EP_NO: N/A Repair Type: Non-Urgent Crossing Status: Found UCIP Comments: 11/16/2016 - Location may be at LM 0.92 (37.935267, -121.332985) rather than LM 0.974. Need to field verify (DWR UCIP - thatch) 8/16/2013 - Pipe abandoned and should be done so properly. (DWR UCIP -wwylie) FIELD_STRUCT_DESC: *Abandoned* 14-inch pipe through the levee 6.0 feet below the crown. Concrete pad for pump on WS shoulder. No pump or other appurtances remain. Originally included in the 1964 O&M manual. FS Date: 8/16/2013

Concrete pad for pump mount on WS shoulder.

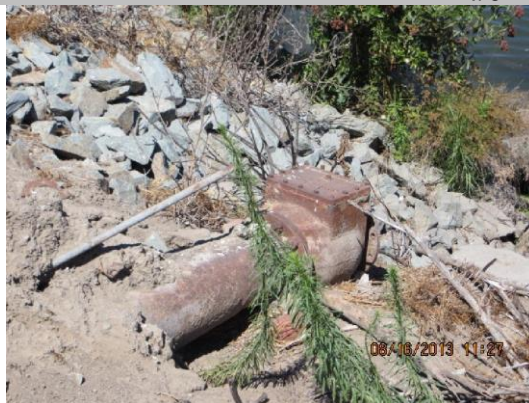
Photo 2 of 3 : UCIP\_SP\_2017\_22724\_38441.jpg

Pipe visible on WS slope.

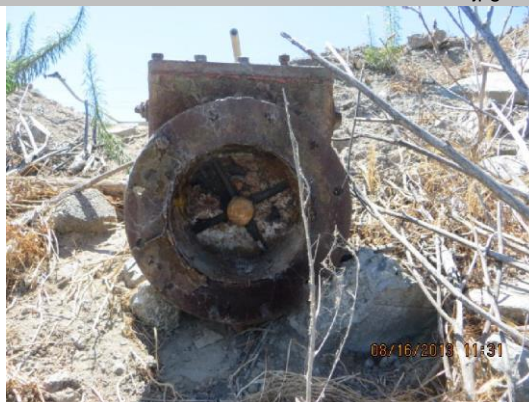
Photo 3 of 3 : UCIP\_SP\_2017\_22724\_38440.jpg

One way check valve closed on WS slope.

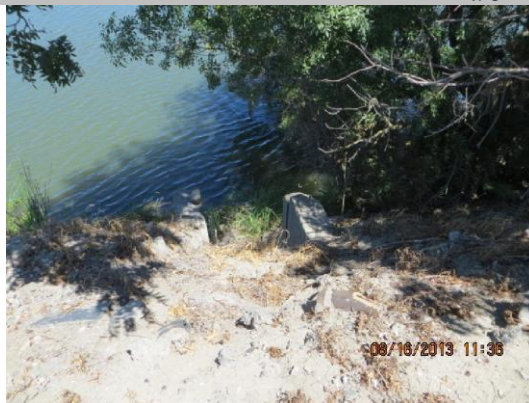
Photo 1 of 2 : UCIP\_SP\_2017\_17575\_29736.jpg

LM Start	0.98	Rating **	A/W	Issue No.	938
LM End	0.98	Issue Type +	Ma	Location *	WS
Category	Supplemental			GPS Latitude/Longitude	
				Start	End
Item	DWR UCIP LMA Responsibility			37.935163 °	37.935163 °
				-121.331887 °	-121.331887 °
DWR ID					
Comment Code					
Inspector Comment					
FS_ID:17575					
DS_ID:20598					
EP_NO: N/A					
Repair Type: No Action Needed					
Crossing Status: Found					
UCIP Comments:					
FIELD_STRUCT_DESC: *ABANDONED* 36-inch pipe through levee					
15.0 feet below crown. Landward end is not visible. Concrete headwall					
at outlet on WS slope is visible. Pipe appears to be abandoned in					
place. Slide gate on waterward side removed. Originally included in					
the 1964 O&M manual.					
FS Date: 8/16/2013

Concrete headwall visible on WS slope.

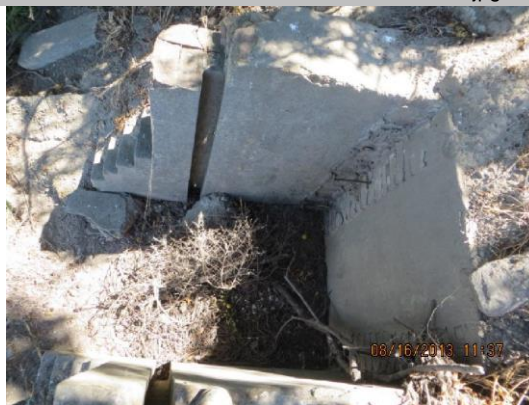
Photo 2 of 2 : UCIP\_SP\_2017\_17575\_29735.jpg

Slide gate removed from headwall on WS slope.

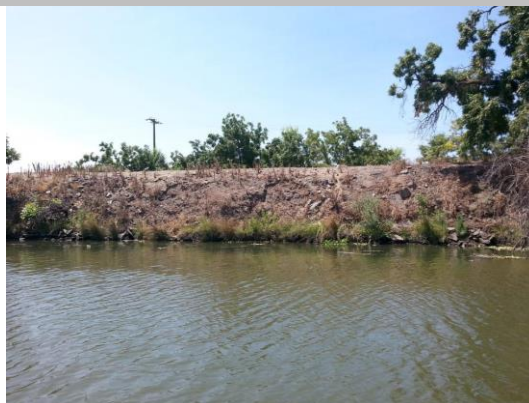
Photo 1 of 2 : SP\_2017\_RD0524\_107\_47\_20170316\_00089.jpg

LM Start	1.00	Rating **	U	Issue No.	47
LM End	1.00	Issue Type +	Ma	Location *	WS
Category	Supplemental			GPS Latitude/Longitude	
				Start	End
Item	DWR Erosion Survey			37.935410 °	37.935410 °
				-121.331560 °	-121.331560 °
DWR ID	DWR_RD0524_01_s_2017_47				
Comment Code					
Inspector Comment					
07/25/2016: No significant change observed.					
06/24/2015: No significant change observed.					
06/19/2014: No significant change observed.					
08/13/2013: No significant change at this site.					
08/07/2012: The erosion was discovered during the boat survey. [2016					
Site ID:RD0524U01RM41.58]

Front view of the erosion.

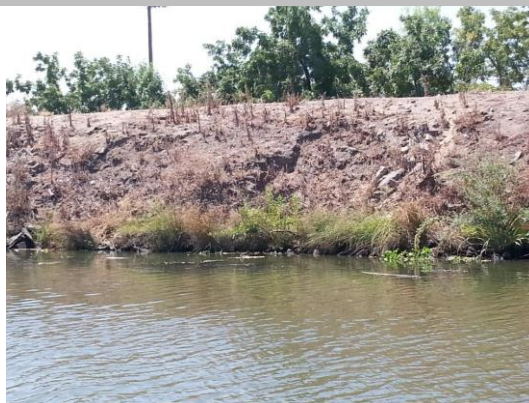
Photo 2 of 2 : SP\_2017\_RD0524\_107\_47\_20170316\_00090.jpg

Close view of the erosion.

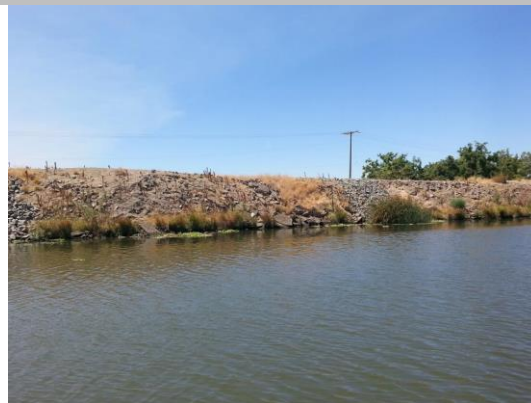
Photo 1 of 3 : SP\_2017\_RD0524\_107\_55\_20170316\_00099.jpg

LM Start	1.02	Rating **	U	Issue No.	55
LM End	1.02	Issue Type +	Ma	Location *	WS
Category	Supplemental			GPS Latitude/Longitude	
				Start	End
Item	DWR Erosion Survey			37.935078 °	37.935078 °
				-121.331134 °	-121.331134 °
DWR ID	DWR_RD0524_01_s_2017_55				
Comment Code					
Inspector Comment					
07/25/2016: No significant change observed.					
06/24/2015: No significant change observed.					
06/19/2014: No significant change observed.					
08/13/2013: No significant change at this site.					
08/07/2012: The site has been visited by boat survey. Site has been repaired, but new erosion occurred at the levee slope and immediately upstream of the repaired site.					
08/23/2011: The site is about 500 ft downstream of bridge. The levee toe seems to be protected, but the protection is being washed away.					
[2016 Site ID:RD0524U01RM41.59]

Upstream view of the site.

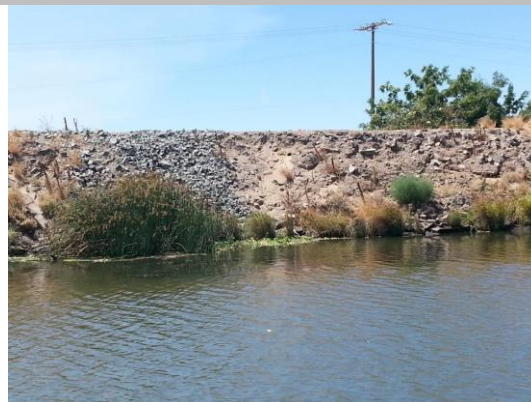
Photo 2 of 3 : SP\_2017\_RD0524\_107\_55\_20170316\_00100.jpg

Close view of the erosion.

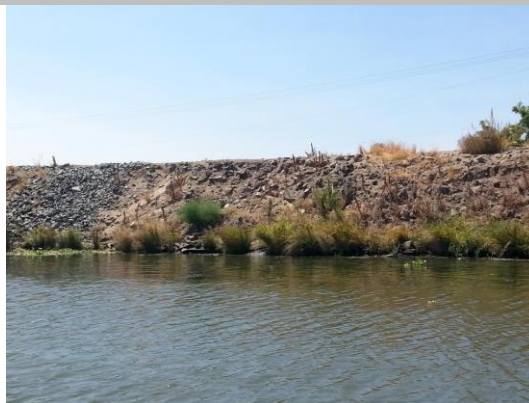
Photo 3 of 3 : SP\_2017\_RD0524\_107\_55\_20170316\_00101.jpg

LM Start	1.02	Rating **	U	Issue No.	55 (cont)	
LM End	1.02	Issue Type +	Ma	Location *	WS	
Category	Supplemental			GPS Latitude/Longitude		
				Start	End	
Item	DWR Erosion Survey			37.935078 °	37.935078 °	
				-121.331134 °	-121.331134 °	
DWR ID	DWR_RD0524_01_s_2017_55					
Comment Code						
Inspector Comment						
07/25/2016: No significant change observed.						
06/24/2015: No significant change observed.						
06/19/2014: No significant change observed.						
08/13/2013: No significant change at this site.						
08/07/2012: The site has been visited by boat survey. Site has been repaired, but new erosion occurred at the levee slope and immediately upstream of the repaired site.						
08/23/2011: The site is about 500 ft downstream of bridge. The levee toe seems to be protected, but the protection is being washed away.						
[2016 Site ID:RD0524U01RM41.59]

Front view of the erosion.

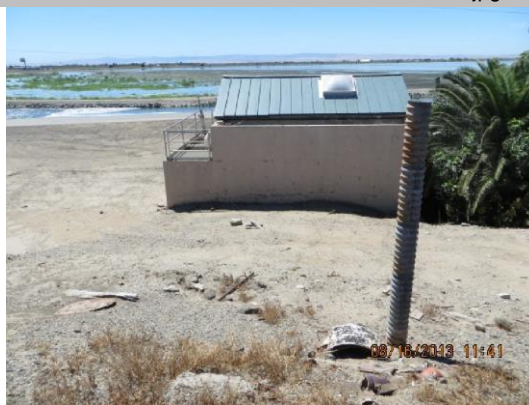
Photo 1 of 2 : UCIP\_SP\_2017\_18703\_31243.jpg

LM Start	1.06	Rating **	M	Issue No.	939
LM End	1.06	Issue Type +	En	Location *	WS
Category	Supplemental			GPS Latitude/Longitude	
				Start	End
Item	DWR UCIP Field Study			37.934778 °	37.934778 °
				-121.330460 °	-121.330460 °
DWR ID					
Comment Code					
Inspector Comment					
FS_ID:18703 DS_ID:20600 EP_NO: 2725B Repair Type: Non-Urgent Crossing Status: Found UCIP Comments: Given amount of rust on adjacent CMP riser, it may be appropriate to do a video inspection of this pipe. FIELD_STRUCT_DESC: 36-inch concrete encased pipe through levee 11.5 feet below crown. Pump in pump house on the landward side. Flap gate on the waterward end. Two concrete cutoff walls. Siphon breaker in 8-inch CMP riser unit on the landward slope (Permit No. 2725B, 1959). Included in the 1964 O&M manual. FS Date: 8/16/2013

8-inch CMP standpipe on LS slope with pump house in background.

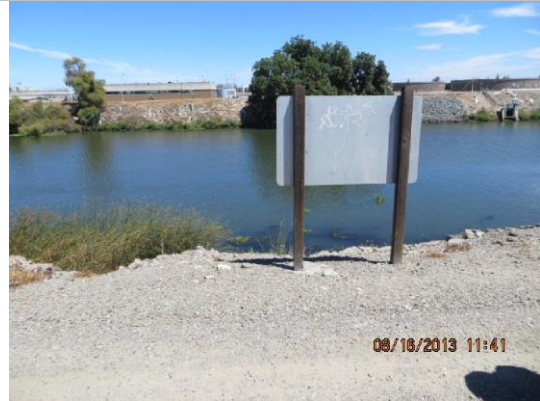
Photo 2 of 2 : UCIP\_SP\_2017\_18703\_31242.jpg

LM Start	1.06	Rating **	M	Issue No.	939 (cont)	
LM End	1.06	Issue Type +	En	Location *	WS	
Category	Supplemental			GPS Latitude/Longitude		
				Start	End	
Item	DWR UCIP Field Study			37.934778 °	37.934778 °	
				-121.330460 °	-121.330460 °	
DWR ID						
Comment Code						
Inspector Comment						
FS_ID:18703						
DS_ID:20600						
EP_NO: 2725B						
Repair Type: Non-Urgent						
Crossing Status: Found						
UCIP Comments: Given amount of rust on adjacent CMP riser, it may be appropriate to do a video inspection of this pipe.						
FIELD_STRUCT_DESC: 36-inch concrete encased pipe through levee 11.5 feet below crown. Pump in pump house on the landward side.						
Flap gate on the waterward end. Two concrete cutoff walls. Siphon breaker in 8-inch CMP riser unit on the landward slope (Permit No. 2725B, 1959). Included in the 1964 O&M manual.						
FS Date: 8/16/2013

Caution sign on WS shoulder for pipe crossings.

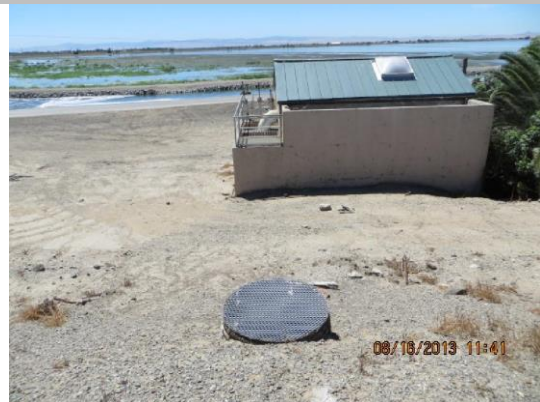
Photo 1 of 3 : UCIP\_SP\_2017\_17589\_29748.jpg

LM Start	1.07	Rating **	M	Issue No.	940
LM End	1.07	Issue Type +	En	Location *	WS
Category	Supplemental			GPS Latitude/Longitude	
				Start	End
Item	DWR UCIP Field Study			37.934750 °	37.934750 °
				-121.330405 °	-121.330405 °
DWR ID					
Comment Code					
Inspector Comment					
FS_ID:17589 DS_ID:20601 EP_NO: 2725B Repair Type: Non-Urgent Crossing Status: Found UCIP Comments: CMP riser severely corroded. Good indicator of potential condition of 48-inch pipe. Recommend Video Inspection. FIELD_STRUCT_DESC: 48-inch CMP sewer line through the levee 16.0 feet below crown. Runs underneath the river and through levee with 36-inch CMP riser/inspection chamber on landward shoulder. Distribution/pumphouse on LS toe (Permit No. 2725B, 1959). Included in the 1964 O&M manual. FS Date: 8/16/2013

CMP riser for access/inspection on LS slope with distribution/pumphouse on LS toe.

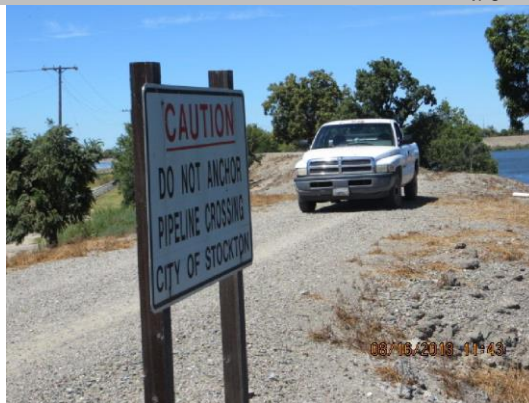
Photo 2 of 3 : UCIP\_SP\_2017\_17589\_29747.jpg

LM Start	1.07	Rating **	M	Issue No.	940 (cont)	
LM End	1.07	Issue Type +	En	Location *	WS	
Category	Supplemental			GPS Latitude/Longitude		
				Start	End	
Item	DWR UCIP Field Study			37.934750 °	37.934750 °	
				-121.330405 °	-121.330405 °	
DWR ID						
Comment Code						
Inspector Comment						
FS_ID:17589 DS_ID:20601 EP_NO: 2725B Repair Type: Non-Urgent Crossing Status: Found UCIP Comments: CMP riser severely corroded. Good indicator of potential condition of 48-inch pipe. Recommend Video Inspection. FIELD_STRUCT_DESC: 48-inch CMP sewer line through the levee 16.0 feet below crown. Runs underneath the river and through levee with 36-inch CMP riser/inspection chamber on landward shoulder. Distribution/pumphouse on LS toe (Permit No. 2725B, 1959). Included in the 1964 O&M manual. FS Date: 8/16/2013

Caution sign on WS shoulder.

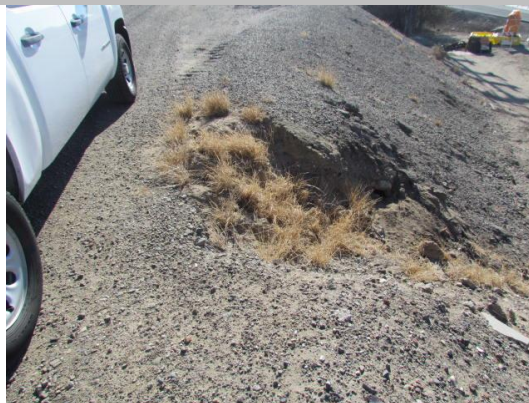
Photo 1 of 7 : SP\_2017\_RD0524\_107\_18\_20170316\_00036.jpg

LM Start	1.07	Rating **	U	Issue No.	18
LM End	1.07	Issue Type +	Ma	Location *	LS
Category	Earthen Levee			GPS Latitude/Longitude	
				Start	End
Item	Slope Stability			37.934715 °	37.934715 °
				-121.330343 °	-121.330343 °
DWR ID	DWR_RD0524_01_s_2012_18				
Comment Code					
S1 : Repair slope instability.					
Inspector Comment					
Slope damage extend from shoulder to middle of slope.

Looking south at caving on landward shoulder. (Fall 2015)

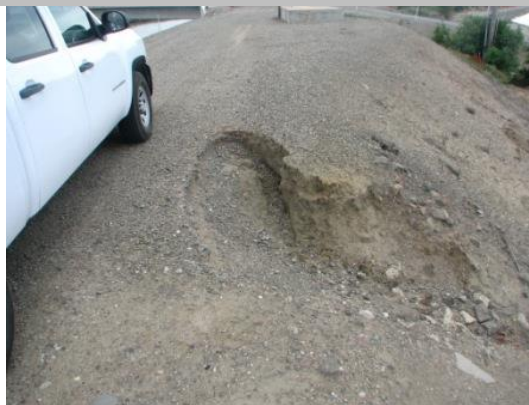
Photo 2 of 7 : SP\_2017\_RD0524\_107\_18\_20170316\_00038.jpg

Landward slope damage. Spring 2014

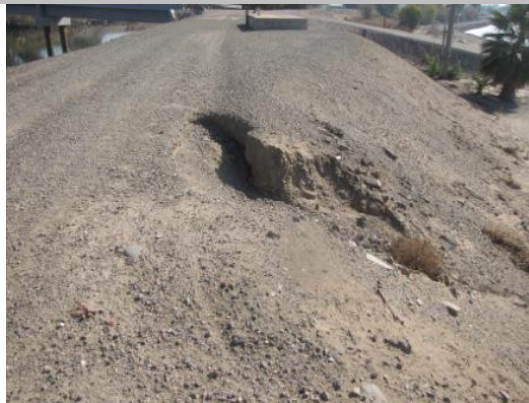
Photo 3 of 7 : SP\_2017\_RD0524\_107\_18\_20170316\_00039.jpg

Updated picture of the erosion site on the landside shoulder. Fall 2014

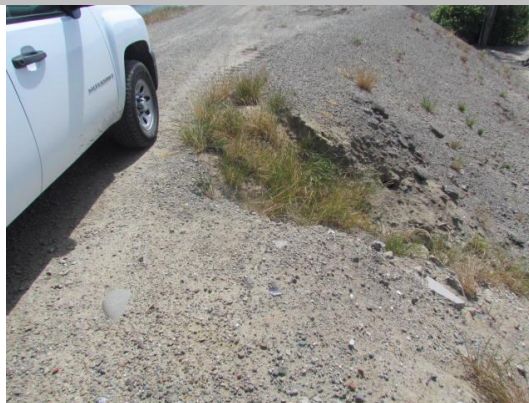
Photo 4 of 7 : SP\_2017\_RD0524\_107\_18\_20170316\_00037.jpg

LM Start	1.07	Rating **	U	Issue No.	18 (cont)	
LM End	1.07	Issue Type +	Ma	Location *	LS	
Category	Earthen Levee			GPS Latitude/Longitude		
				Start		End
Item	Slope Stability			37.934715 °		37.934715 °
				-121.330343 °		-121.330343 °
DWR ID	DWR_RD0524_01_s_2012_18					
Comment Code						
S1 : Repair slope instability.						
Inspector Comment						
Slope damage extend from shoulder to middle of slope.

Looking south at caving on landward shoulder. (Spring 2015)

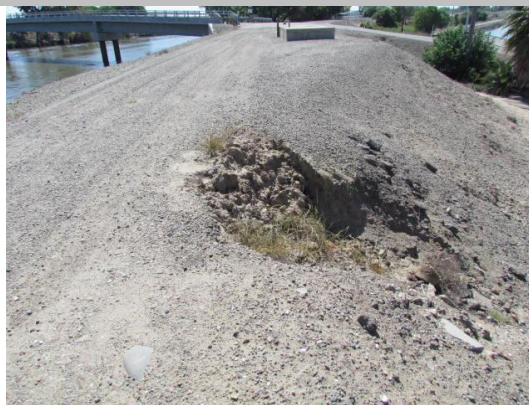
Photo 5 of 7 : SP\_2017\_RD0524\_107\_18\_20170316\_00040.jpg

Looking south at caving on landside shoulder. (Spring 2013)

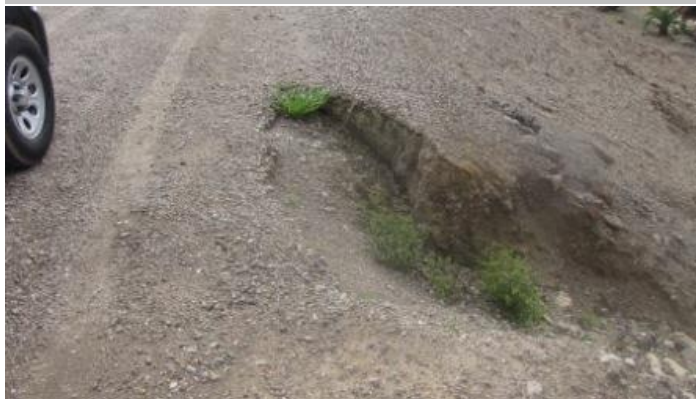
Photo 6 of 7 : SP\_2017\_RD0524\_107\_18\_20170316\_00041.jpg

Looking at updated slope stability as of Fall 2013.

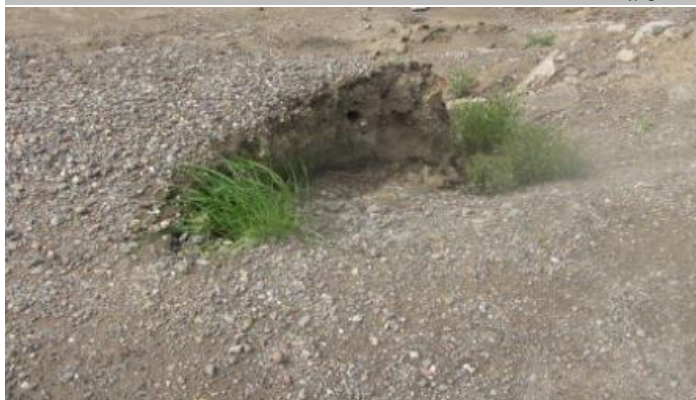
Photo 7 of 7 : SP\_2017\_RD0524\_107\_18\_20170316\_00042.jpg

LM Start	1.07	Rating **	U	Issue No.	18 (cont)	
LM End	1.07	Issue Type +	Ma	Location *	LS	
Category	Earthen Levee			GPS Latitude/Longitude		
				Start		End
Item	Slope Stability			37.934715 °		37.934715 °
				-121.330343 °		-121.330343 °
DWR ID	DWR_RD0524_01_s_2012_18					
Comment Code						
S1 : Repair slope instability.						
Inspector Comment						
Slope damage extend from shoulder to middle of slope.

Updated view from above the slope stability.

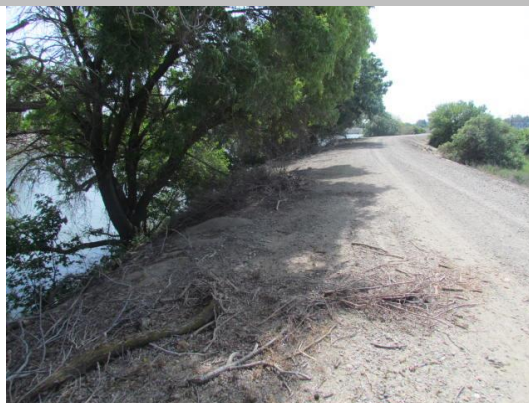
Photo 1 of 1 : SP\_2017\_RD0524\_107\_171\_20170316\_000200.jpg

LM Start	1.12	Rating **	M	Issue No.	171
LM End	1.16	Issue Type +	Ma	Location *	WS
Category	Earthen Levee			GPS Latitude/Longitude	
				Start	End
Item	Encroachments			37.934225 °	37.933815 °
				-121.329693 °	-121.329242 °
DWR ID	DWR_RD0524_01_s_2015_171				
Comment Code					
PR : Prunings					
Inspector Comment					
Prunings left on waterward shoulder and slope.

Looking south at prunings on waterward shoulders.

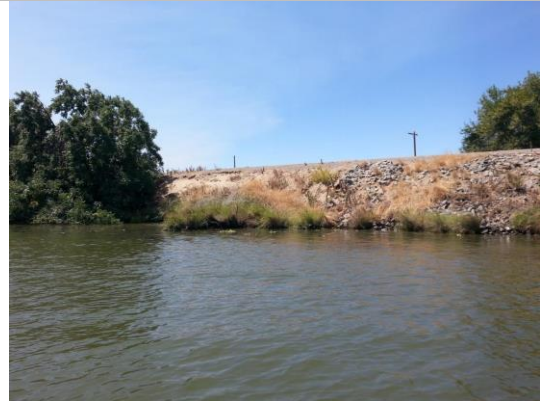
Photo 1 of 3 : SP\_2017\_RD0524\_107\_60\_20170316\_00105.jpg

Comment Code					
Inspector Comment					
07/25/2016: No significant change observed. 06/24/2015: No significant change observed. 06/19/2014: No significant change observed. 08/13/2013: No significant change at this site. 08/07/2012: The site has been visited by boat survey. No significant change observed 08/23/2011: No significant change observed on site. 09/07/2010: No significant change observed on site. Vegetation is visible at the water line. There is an exposed pipe discharge partially hanging at the mid-slope, possibly still used for discharging irrigation/runoff water. There is minimal rip rap protection along the bank, and what's left of it is no longer adequately protecting the bank. 9/29/2009: Site consists of a 400-foot long eroding bank with minimal vegetation and protection; the existing rip rap has sloughed, rendering it useless; note that there is an exposed section of a pipe. 10/18/2006: There is extensive loss of rip rap on some sections; sewage disposal pond is on the landside of the levee; there is an exposed pipe outlet "hanging" from the upper slope. [2016 Site ID:RD0524U01RM41.79]

Direct view of the site.

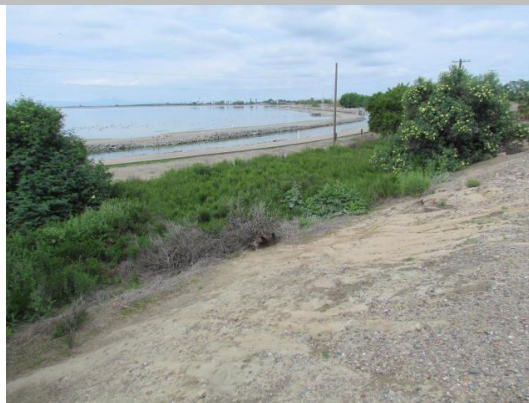
Photo 2 of 4 : SP\_2017\_RD0524\_107\_915\_20170316\_00270.jpg

Looking northwest at dense veg at landward toe and berm. (Spring 2016)

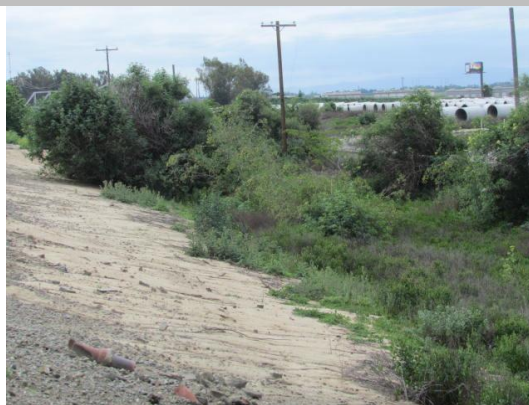
Photo 3 of 4 : SP\_2017\_RD0524\_107\_915\_20170316\_00271.jpg

Looking southwest at dense veg at landward toe and berm. (Spring 2015)
